# "The largest and most complex 'DIY' self-build personally carried out by the "Self-Build-Pro" himself!"

## "Defying Gravity"!

*Location: Rural Wiltshire (UK)*

**When the sub-contractors went 'AWOL' at the last minute; the "Self-Build-Pro" personally saved the day by stepping into the 'breach' to build his thirteenth timber-framed house in 30 years!**

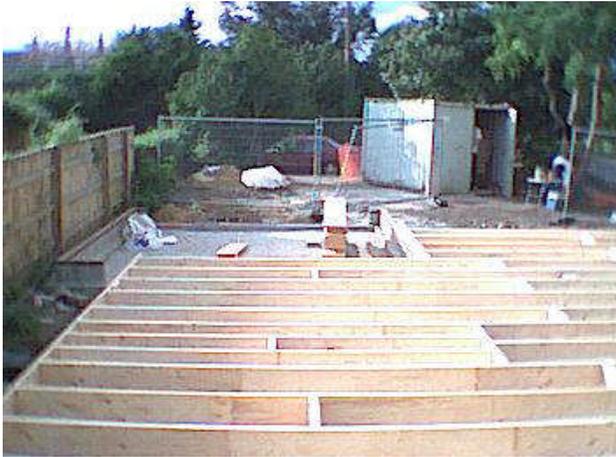
As can be seen; the whole ground floor, apart from the garage area, is a suspended LVL joist floor above the oversite concrete "blinding". The garage area will have a concrete "beam & block" floor topped off with a reinforced cement & sand screed.

As the neighbour wouldn't agree to the garage wall face forming the actual property boundary, the foundations were cast around the boundary fence posts to get the wall as close as possible to the rear of the fencing!

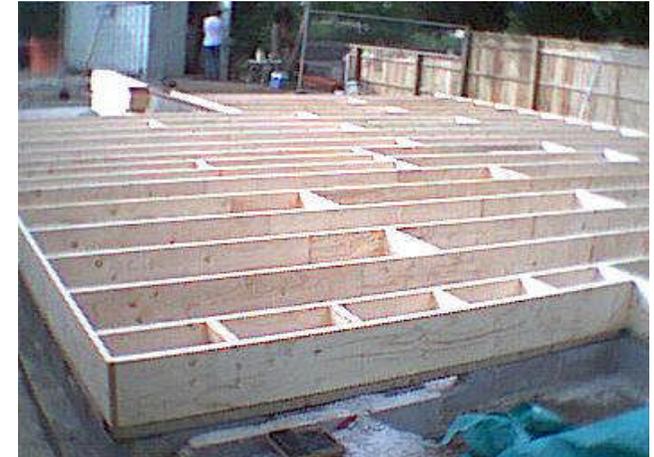
The "pattern" of solid blockings can be clearly seen above.

The main floor-joists are 9.3 m / 30'6" long at 600 mm centres **with solid blockings to alternate spans so as to brace each joist at quarter spans.** (A typical ProFrame® solution that is far more efficient than using of multiple rows of steel or timber "herringbone strutting" between the joists!)

Joists parallel to the external wall have noggins at 600 mm centres to brace the rim-joist and provide support under the wall-panels.

The ground and first floor joists; upto 10.6 m / 34'9" long; were cut and fitted single-handed with blockings only provided to alternate spans - which meant the floor-joists were fully-braced at quarter spans - without incurring all the usual costly 'full-strutting' - they also cost less than 70% compared to the cost of using 'I' joists as well as being quicker to complete with no 'web-stiffeners', etc. to worry about either.

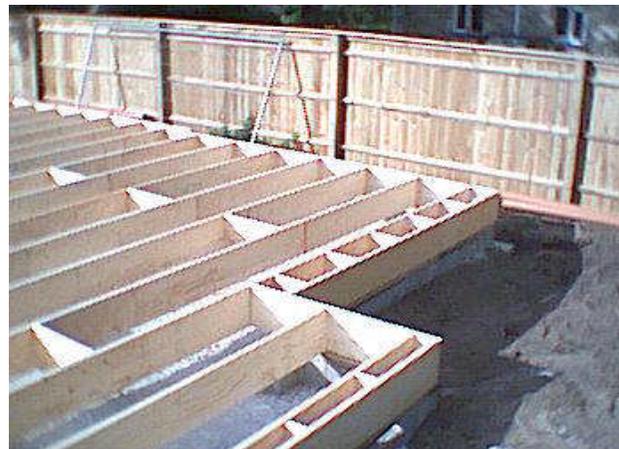
The suspended floor construction was a late change after the groundworks sub-contractor excavated the foundation trenches and discovered that the vegetable (top) soil extended nearly 90 cm / 3'0" below the surface over the whole area!

(It was cheaper and quicker to frame-up a LVL joist floor than use concrete "beam & block" and much, more eco-friendly too.)

As there was a risk of water penetration into the underfloor 'quilt' insulation; that would have rendered the insulation permanently useless; it was decided to leave the floor deck open during erection of the house and to fit the insulation after the house was weathertight. The plywood floor sheathing sheets were to be 2400 mm x 1200 mm (8' x 4') nominal T&G all edges so the entire perimeter of the house floor was fitted with 200 mm / 8" wide floor sheathing strips; groove-edged along one long side with 45 degree splayed-edge along the opposite long side and similarly to front and rear edges of the house floor - thus facilitating an easy fitting of the floor sheathing later with no loss of edge support!

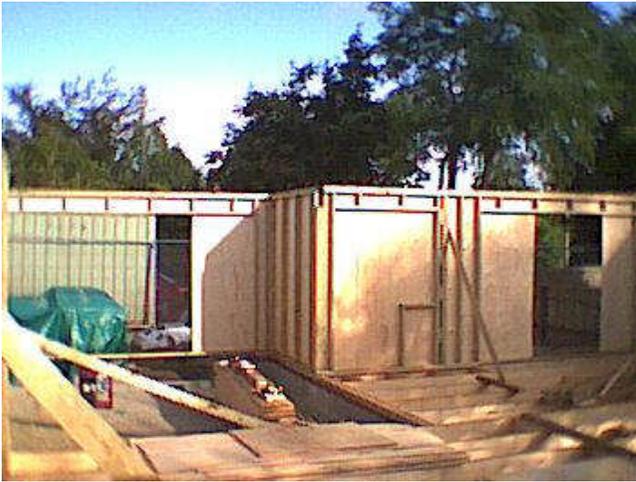
Ground floor wall-panels erected to front of Lounge & Hallway with Garage to left - ***note the lack of lintels over all the structural openings*** including the garage door!

Outside the 'Lounge' wall-panels (see right) projects the base for the splayed bay window ready for the under-sill wall-panels to be framed and fitted later.

Despite the usual provision of lintels over all external wall openings in timber-frame houses; our ProFrame<sup>®</sup> software also 'designed-out' the need for any lintels over seventeen of the nineteen external openings in this house. It also 'designed-out' the need for internal load-bearing walls and the need for foundations under them; despite the revised roof design rendering the original roof truss support points totally inadequate!

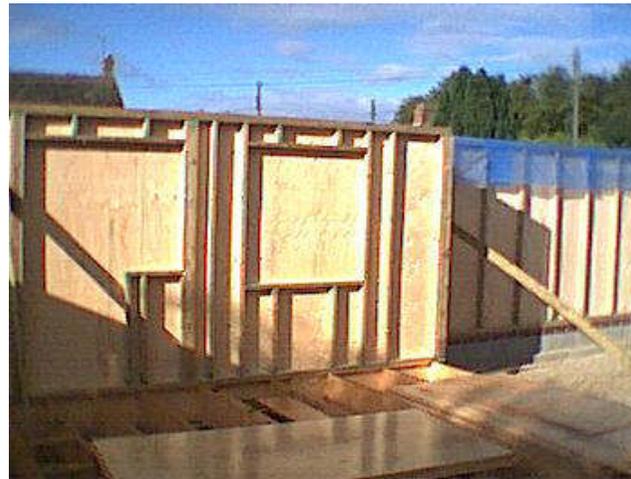
Whenever there are two or more wall-panels in the same wall-length, the wall-panels are supported with temporary bracings; until the first floor joists are fixed and fully sheathed to provide full structural integrity to the ground floor walls.

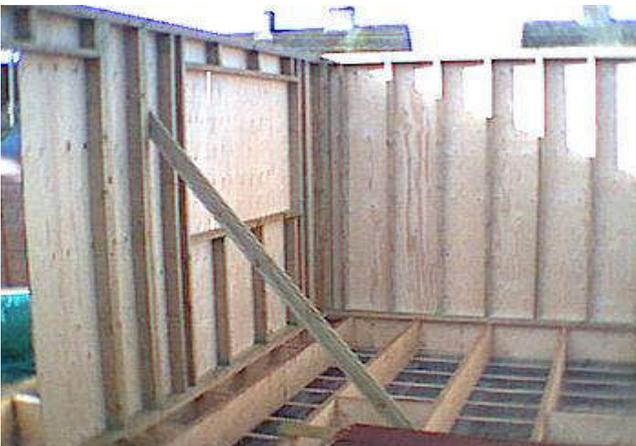
Wall-panels around the Kitchen area. The framing to the side wall of the Kitchen is the ***only*** section in the entire house with framing at 400 mm (16") centres due to the higher weight-loads carried by that section of wall. Everywhere else the framing is at 600 mm (24") centres.

The picture (left) also shows the "laths" nailed to the underside of the floor joists ready to support the underfloor insulation quilt.

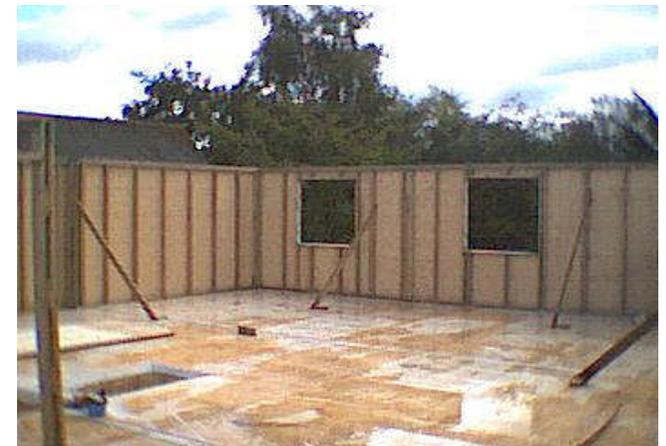
From the outside; the rear of the house looks quite strange with breather membrane overlaid with adhesive tape marking the framing positions ready for the bricklayers to nail stainless steel cavity ties when the reconstituted stone (Bradstone) outer veneer is built. The breather is being cut and pinned back around the openings ready for the timber fire-stops and windows to be fitted in place.

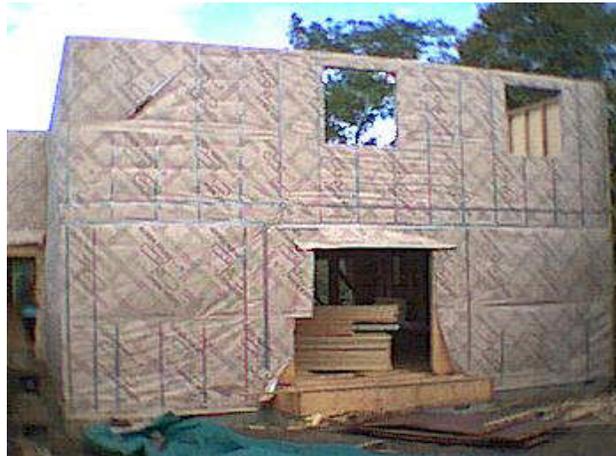
The picture on the previous page (bottom-right) shows the same window openings from inside the house. The polythene sheeting over the first floor sheathing is only there to minimize the risk of "water staining" as the sheathing will be the final finish before carpets are laid.

Note all the temporary bracings to the wall-panels which will remain in place until all the roof trusses are fixed and fully braced to provide structural integrity to the first floor walls.

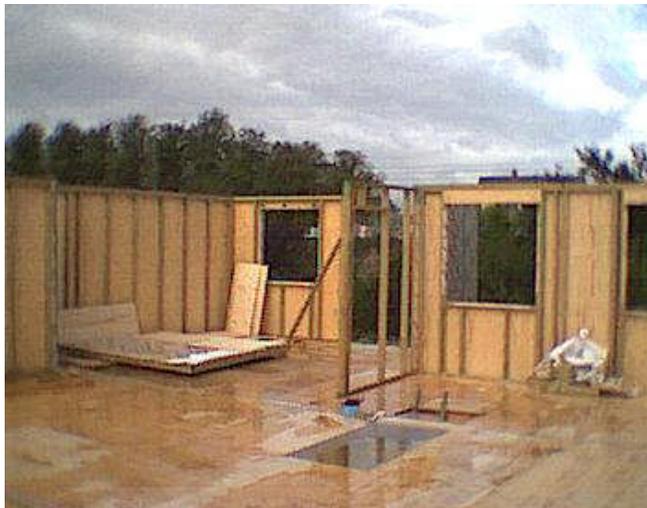
Two views showing the wall-panels at the front of the house; looking into the Master Bedroom area on the left and Landing/Bedroom 2 area on the right; the last wall-panel - lying on the Master Bedroom floor - won't be fixed until the roof trusses have been lifted and stacked on the first floor deck.

The picture to the right *shows the only two structural openings with lintels over*; that's just two openings out of an overall total of nineteen openings in the structural walls! (All external openings would normally have timber lintels but ProFrame® is a 'bespoke' design system that saves time, labour and material by 'designing-out' everything that isn't actually needed!)

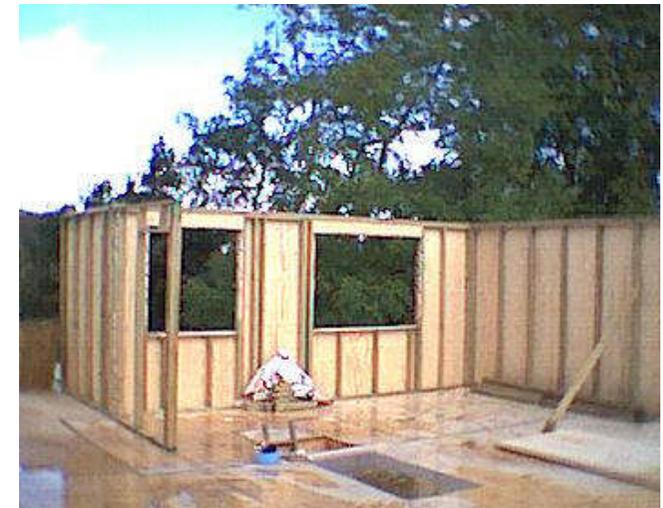
This view (left) across a neighbour's garden shows the Master Bedroom windows have been fitted but not the main Bathroom window on the side!

(The "projection" above the wall is the end of a roof truss propped against the inside of the wall!)

Note the absence of scaffolding! The ProFrame® system doesn't require the use of scaffolding or hoisting gear - even when working completely alone!

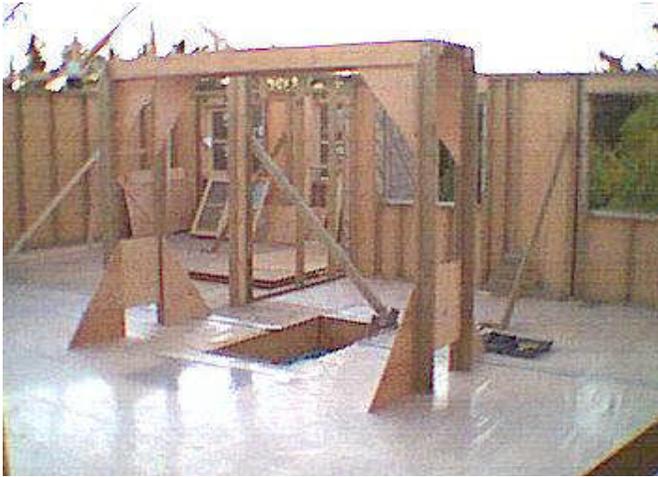
However; even with all his experience the Self-Build-Pro still needs to be able to get up to "ceiling" level in order to lift and fix roof trusses - the solution is the simple 'work-platform' he has constructed for the task as shown in the picture on the next page (top-left)!

(The bracing "gussets" have been cut from scrap wall sheathing plywood; the "legs" are four lengths of 100 x 50 (4"x2") CLS timber; the top is cut from scrap floor sheathing plywood and supported on a couple of lengths of cut-down LVL floor-joists.)

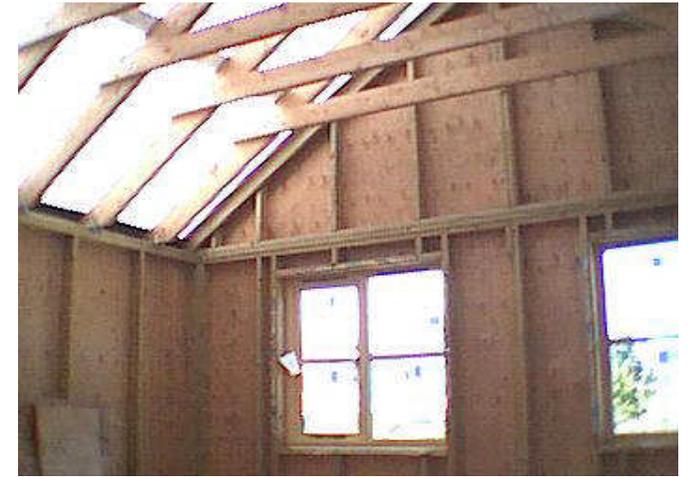
The "cathedral" ceiling with exposed ties over the Master Bedroom (seen above) was the only part of the entire roof structure not using trussed rafters **AND** having both ends supported on external walls.

None of the roof trusses had both ends supported on external walls ~ several had neither end bearing onto a wall ~ being supported solely by girder trusses each end (as can be seen in the picture on the left). Even the girder trusses only had only one end supported on an external wall!

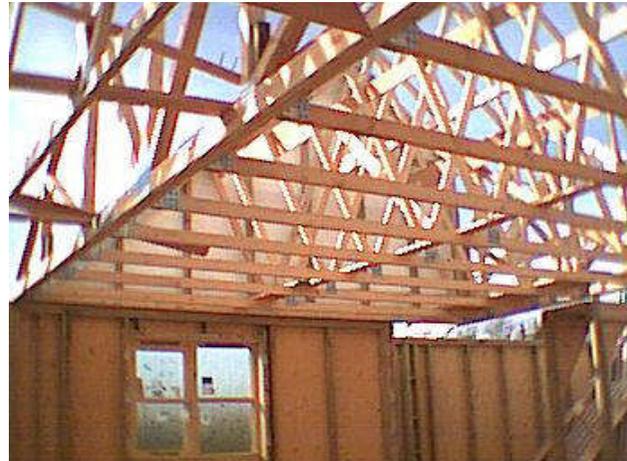
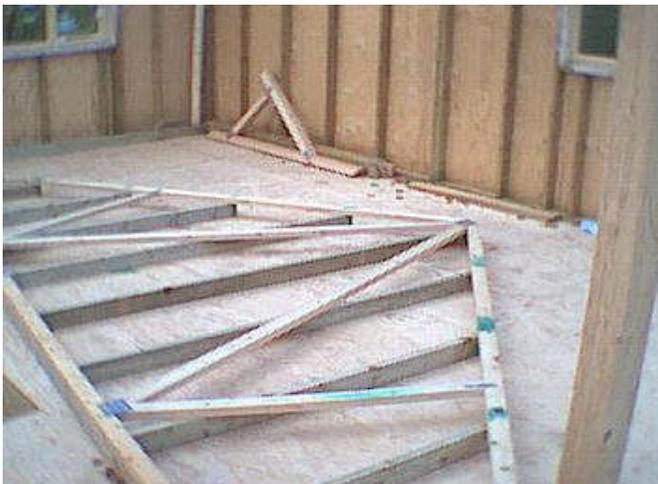
Apart from the gable wall to the upper part of the Master Bedroom shown in the view above (top-right); all other gables used the relevant roof truss as a fully braced "template" for the vertical framing, thus avoiding the need for any sheathing, with the (roofing grade) breather membrane simply being fixed over the open framework (seen left)!

Hence the "grey" gable in the view on the right and at the top (centre) of the next page!

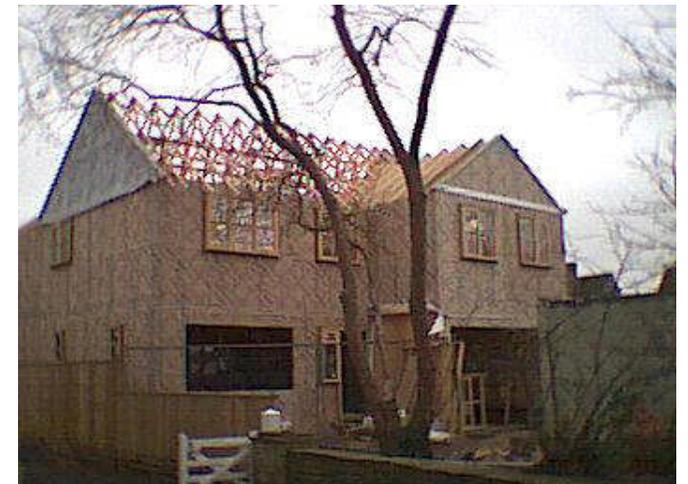
The work to close in the roof and make it weathertight was done from the "inside"; i.e. without the need for any scaffolding; that left just a small final piece of the roof breather membrane (seen above the guttering to the Master Bedroom in the picture below) to be secured using a ladder for external access.

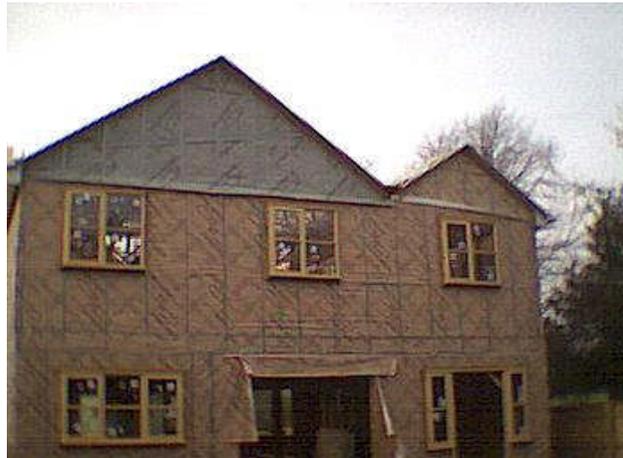
The views left and below left both show progress on getting gable undercloaks fitted, with the eaves fascia-boards, soffites and rainwater gutters also fitted. The roof breather-membrane has also been fitted and is held in place with plywood counter-battens. (Note the two 'Velux' roof windows can also be seen on the roof above the Master Bedroom.)

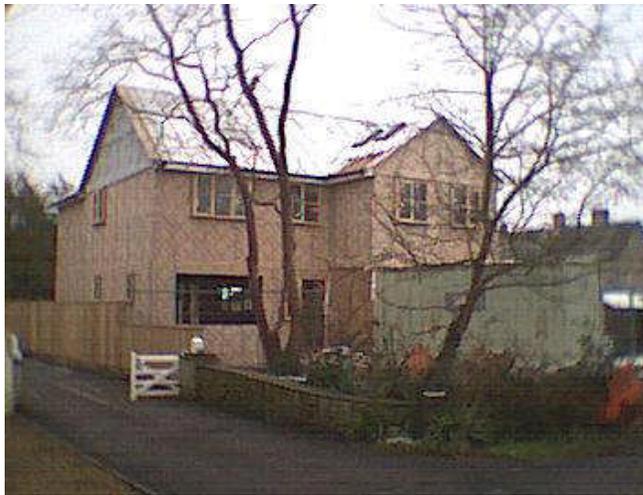
Having created and secured a weather-tight house, the Family Room annexe is finally framed up and erected. The "French" door-frame and windows came pre-assembled as a single unit although; due to the weight involved; the double-glazing units were supplied 'loose' for installation after the door/window unit had been fitted into place!

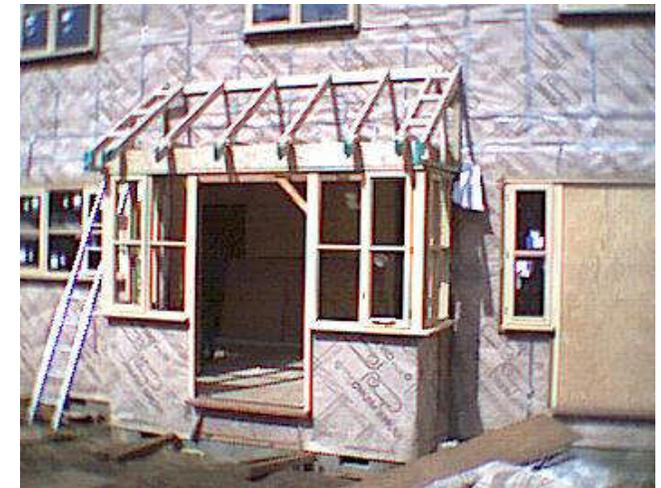
As the roof over the Family Room annexe was a straightforward "lean-to" sloping roof, it allowed the rafters to be fixed straightaway directly to the main house wall-panels, together with fascia-board, breather-membrane, etc.

The "stone" claddings will 'span' across the roof; above the sloping rafters; on a standard steel "outer skin" cavity lintel set immediately above the top of the rafters.

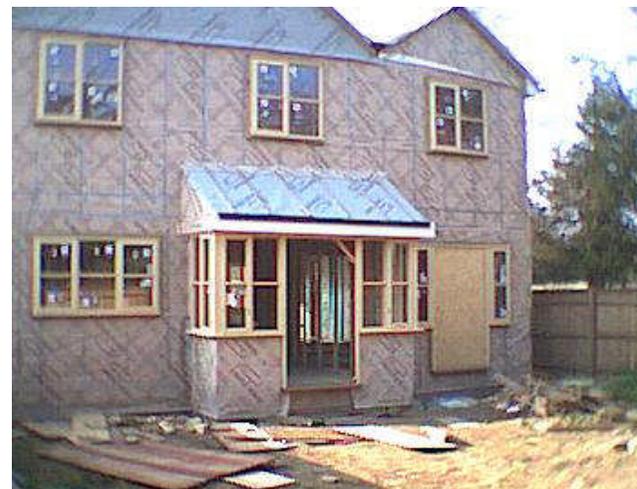
Having a 'hipped' roof; the Lounge splayed bay window posed a more awkward problem. The "stone" claddings will have an overlap with the window opening from both sides and so will be supported off a standard steel "outer skin" lintel fixed immediately above the bay window's ceiling joists ~ hence the temporary "roof" made out of breather-membrane to keep it weathertight ~ seen in the view (top-left) on the next page!

The rafters will be "planted-on" to the front of the "stone" cladding after it is built.

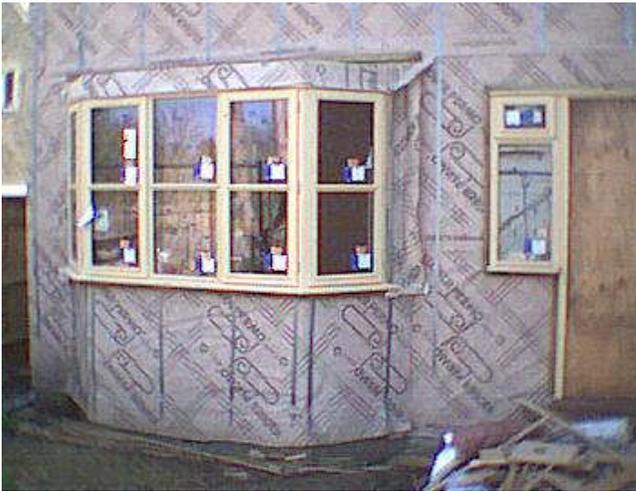
The view (right) shows the same view seen on the previous page (middle-left) but with the Lounge bay window fitted. The roof breather-membrane has also been finished off above the Master Bedroom!

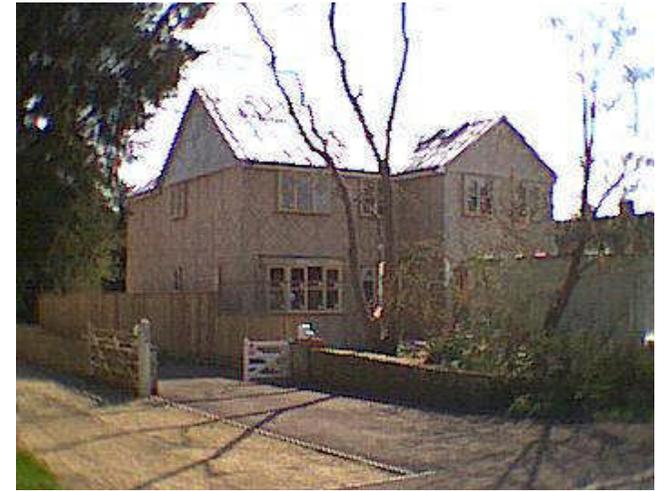
Whilst the outside is ready for the bricklayers to arrive and start building the "Bradstone" outer skin; inside the house, the ground floor insulation quilt was laid between the joists and the floor sheathing cut and laid so all the internal walls could be framed up and fixed into place.

With that done; 90 mm (3.5") thick foil-faced urethane insulation is already being fitted around the external walls as seen below.

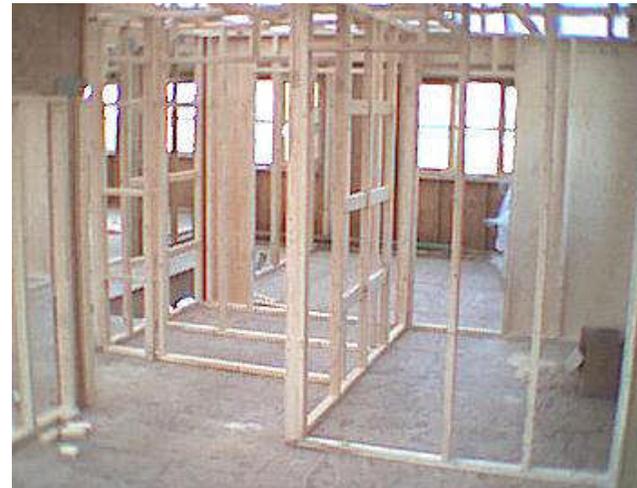
Upstairs; partition walls forming the 'ensuite' second bathroom serving Bedrooms 2 & 3 and the respective back-to-back built-in wardrobes ~ are seen in the view (left) ~ as viewed from Bedroom 3. The Landing and stairwell "hole" can just be seen beyond the studding!

With ground floor insulation completed; cutting and fitting of the 90 mm (3.5") thick foil-faced urethane insulation around the upstairs' external walls will follow shortly!

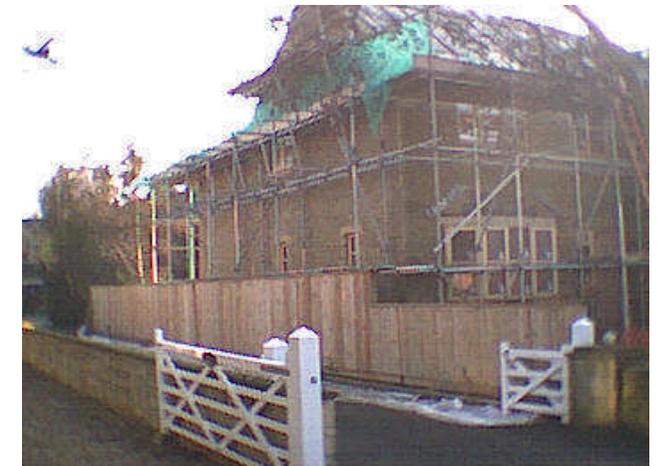
The frontal view (right) shows the "Bradstone" wall cladding is virtually completed on a dull, wet day and everything almost ready for the stone roof slates to be laid - whilst the view below shows the same elevation just a few days later with the stonework and roofing completed and the scaffolding gone!

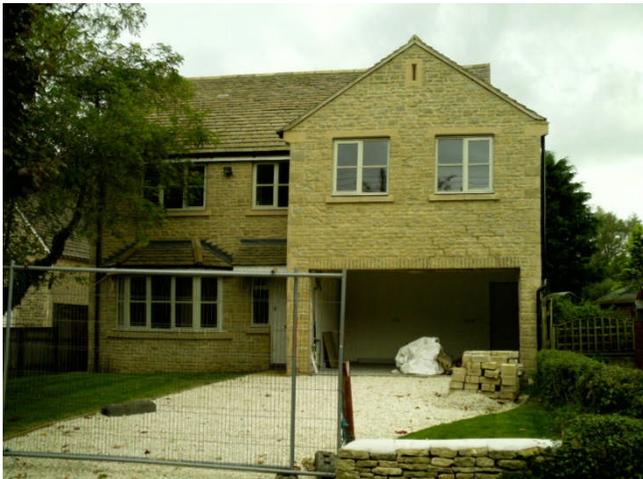
Similarly; the view on the previous page (bottom-right) was also transformed by the removal of the scaffolding after completion of the stonework and roofing; as shown by the view seen below!

The views above and left show the two "master-bedroom" windows above the garage doorway, with Landing and Bedroom 2 windows to the left. Downstairs is the front door, Hallway window and the Lounge bay-window!

The frontal view also illustrates how tight the site width is - whilst there is a 900 mm pathway between house and fence; the opposite side has the wall-face virtually touching the fencing!

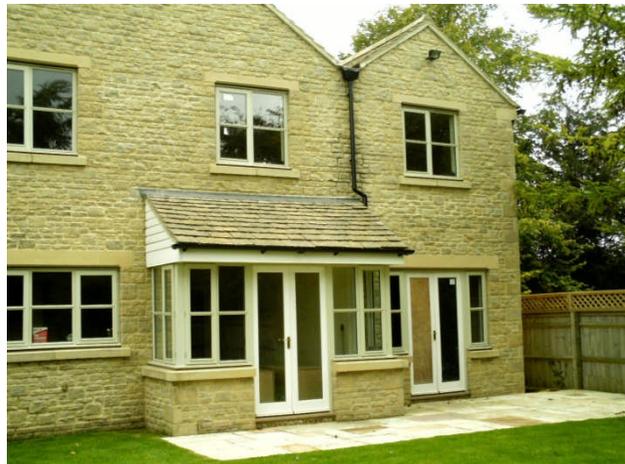
The view left shows the finished version of the earlier rear view of the house seen two pages earlier!

Upstairs are the windows to Bedrooms 3, 4 & 5; downstairs the Kitchen window is seen on the left with the "annexe" to the Family Room in the middle and the Dining Room "French doors" on the right; below the window to Bedroom 3.

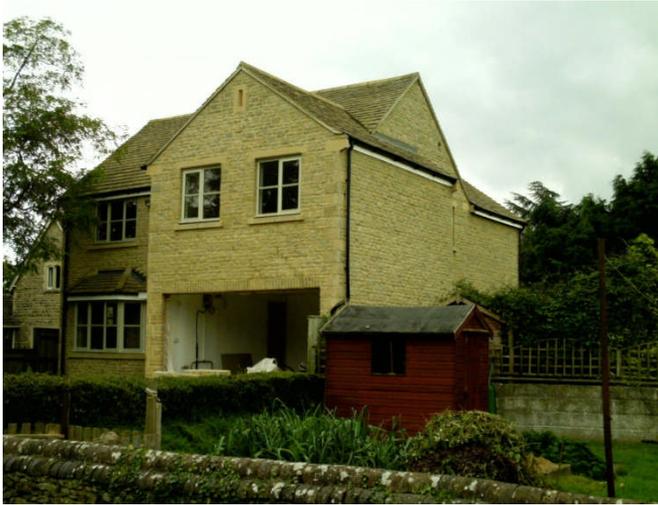
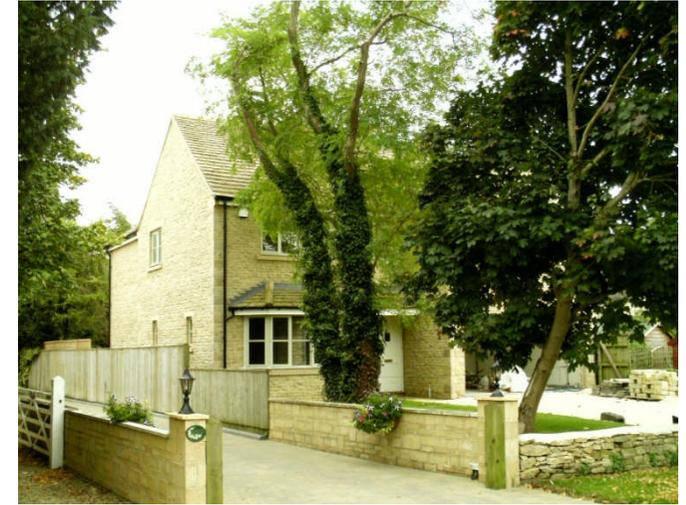
The final two views show the finished\* house resplendent in its "Cotswold" stone claddings (Bradstone) as seen from across one neighbour's garden and the other neighbour's drive respectively.

\*The 'bespoke' overhead garage door had been removed for (car) damage to be repaired!

Despite the trees now being in full leaf - the views compare well with the same views - as seen five pages and two pages earlier respectively - taken at an earlier stage of construction.
